# **CASTING BASIN GATE MAINTENTANCE RECORDS**

CYCLE 6

# Kiewit-General Inspection Report

**PROJECT:** SR 520 PONTOONS

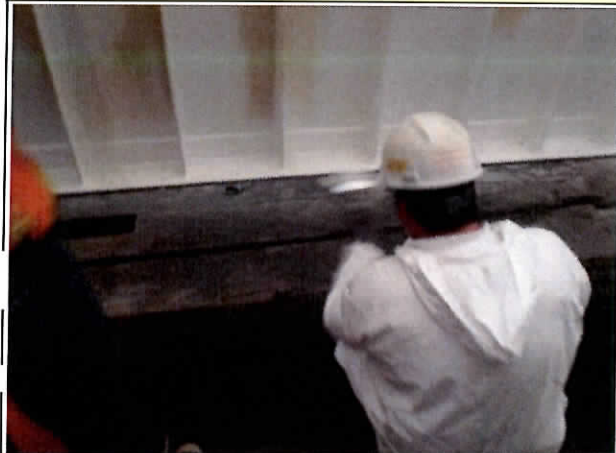
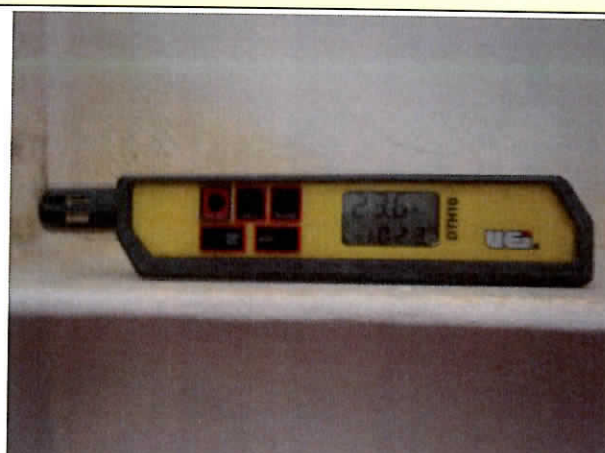
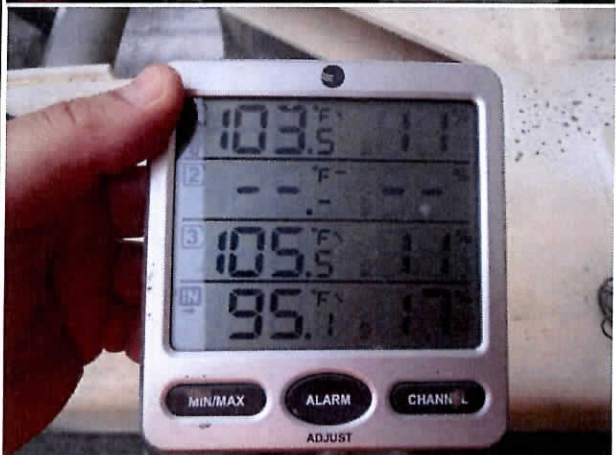
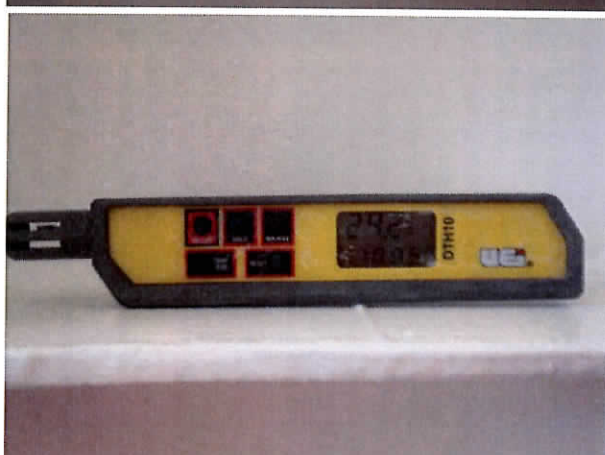
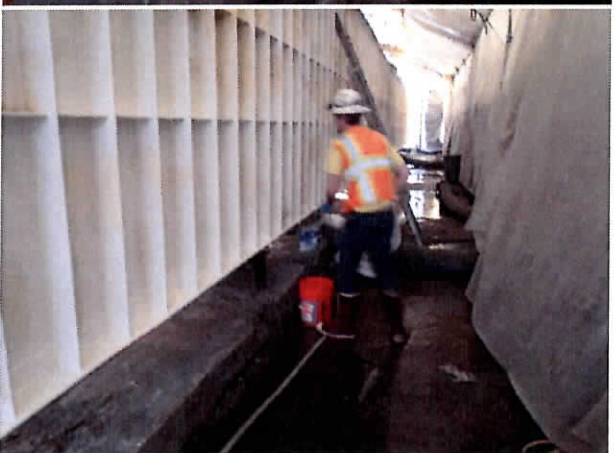
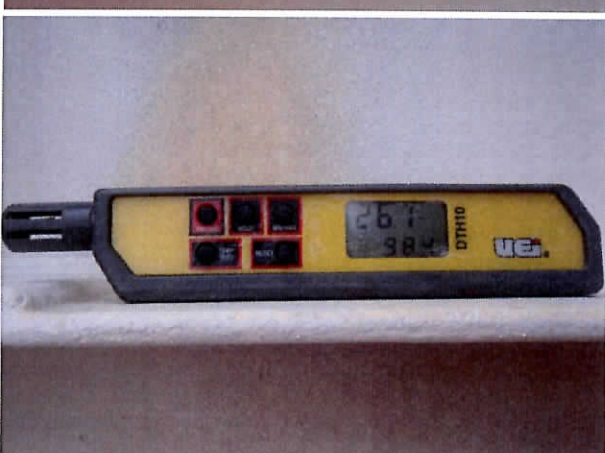
IDR Sheet Sheet 5 of 17	QA Key Personnel Function Structural Inspector	Date Monday, March 23, 2015
Inspector Doug Brinius	IDR Report # 3/23/2015 DB	
Inspector's Notes Continued

TOP SIX: Truss 2/3 holiday testing, T2/T3 tent temperature readings

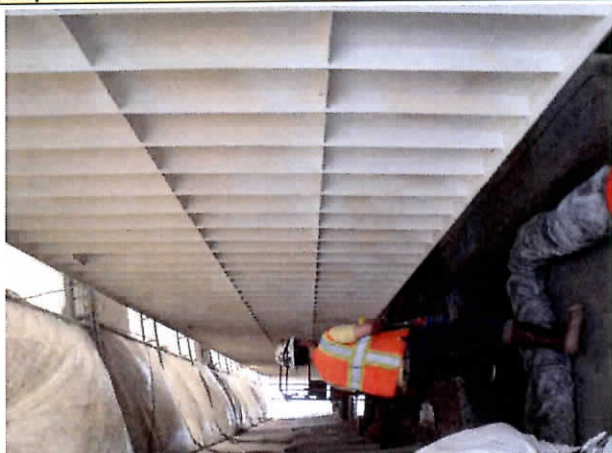
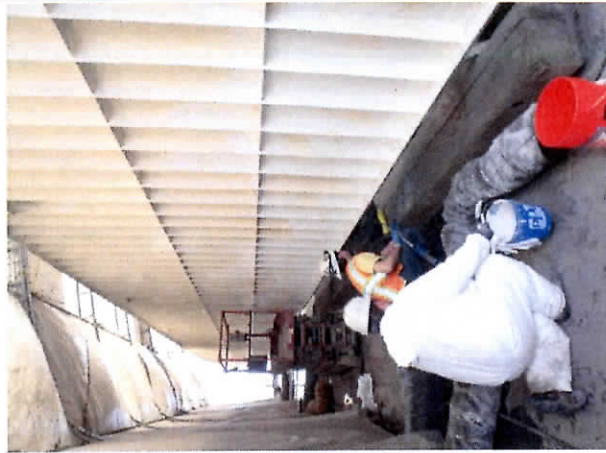
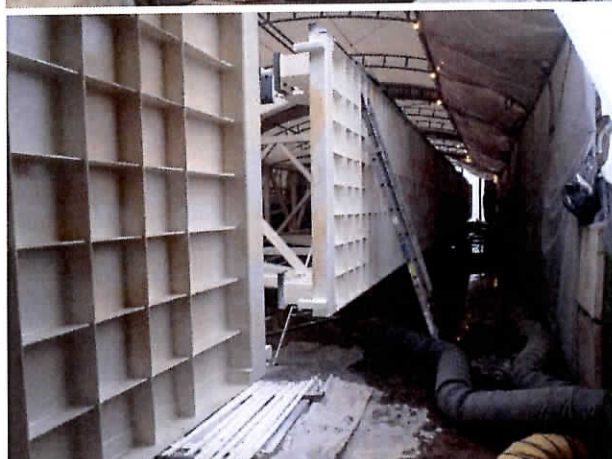
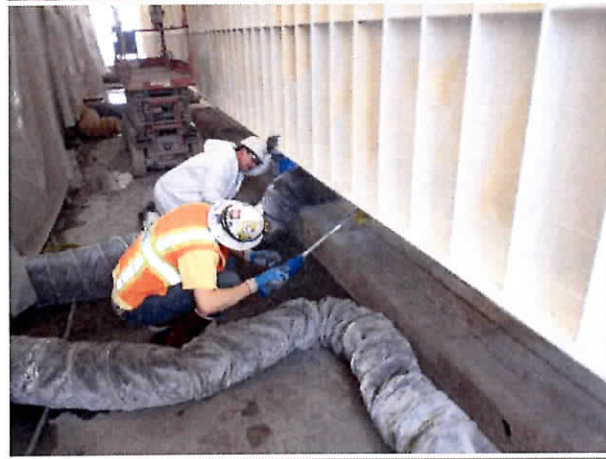
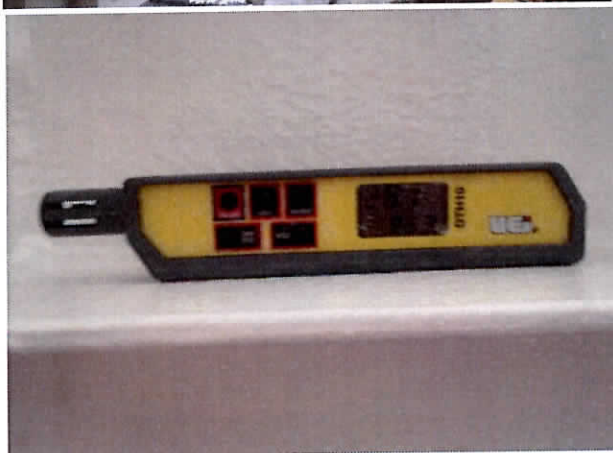
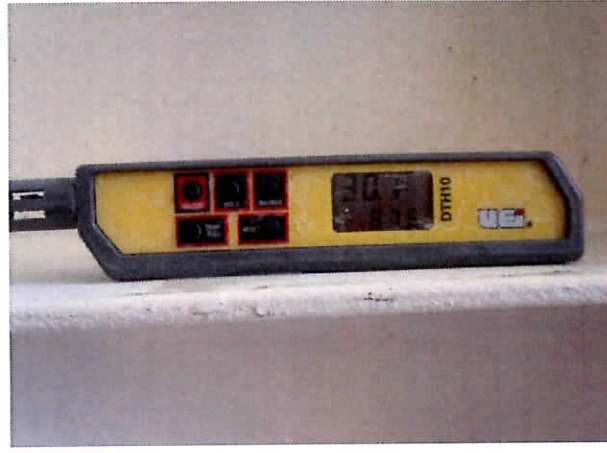
IDR Sheet		QA Key Personnel Function		Date
Sheet	6 of 17	Structural Inspector		Monday, March 23, 2015
Inspector		IDR Report #		
Doug Brinius		3/23/2015 DB		
Inspector's Notes Continued

TOP SIX: Truss 2/3 holiday testing, T2/T3 tent temperature readings

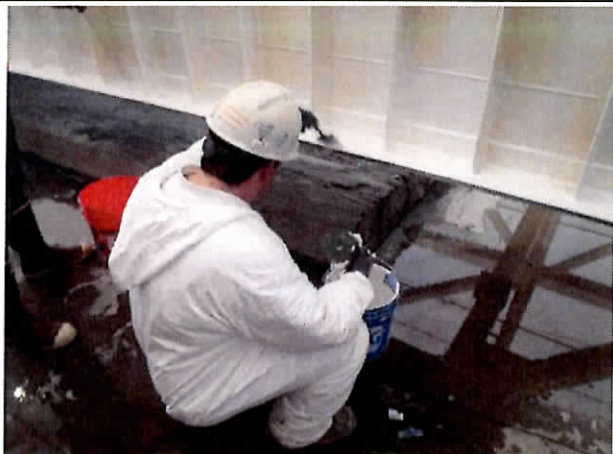
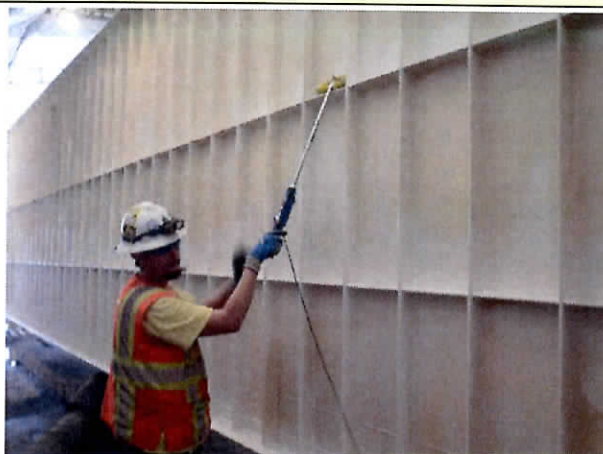
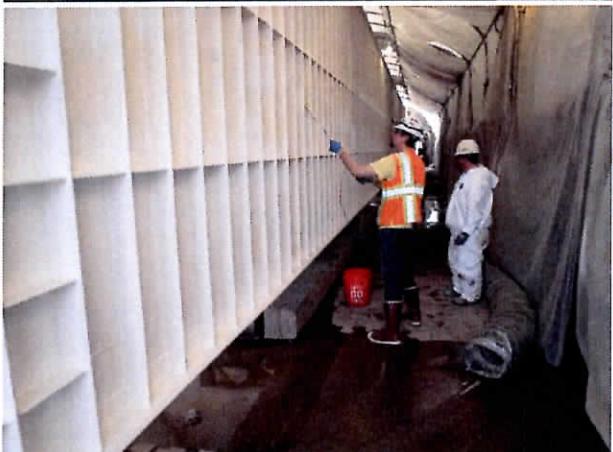
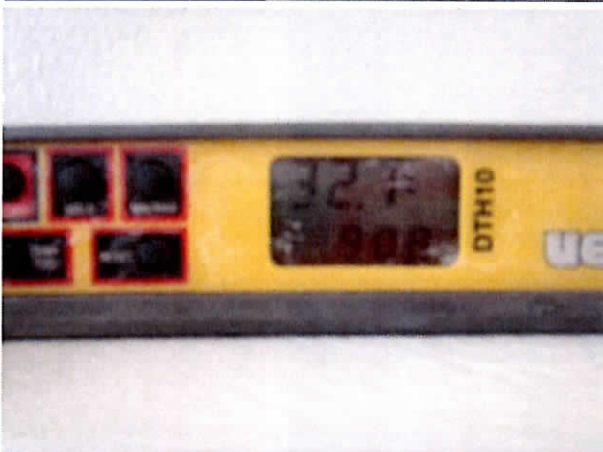
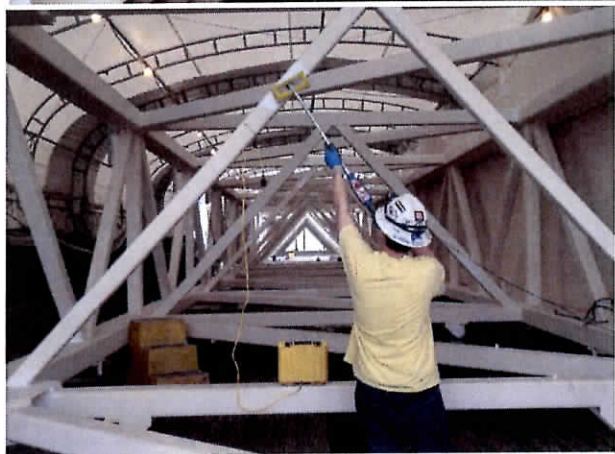
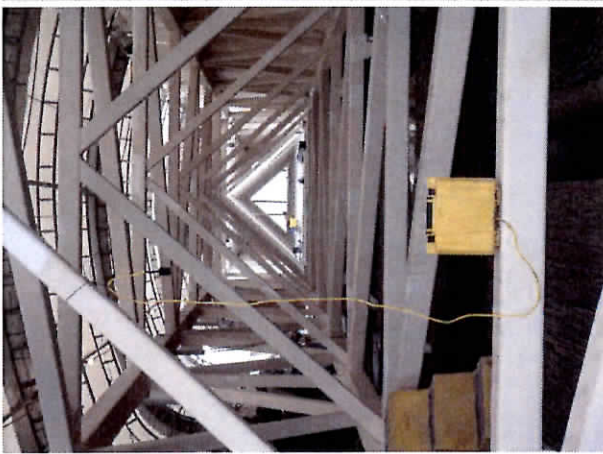
TOP SIX: Truss 2/3 holiday testing, T2/T3 tent temperature readings

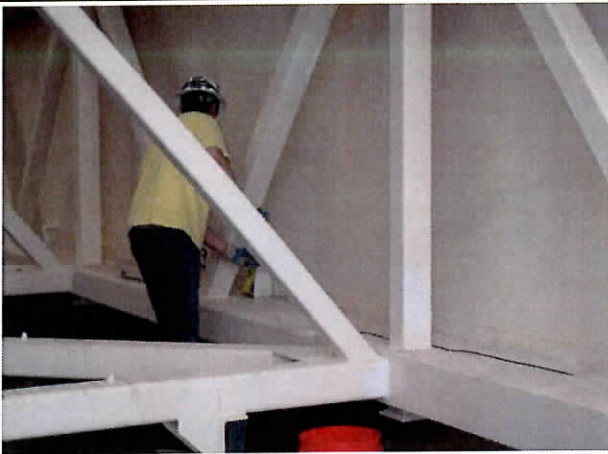
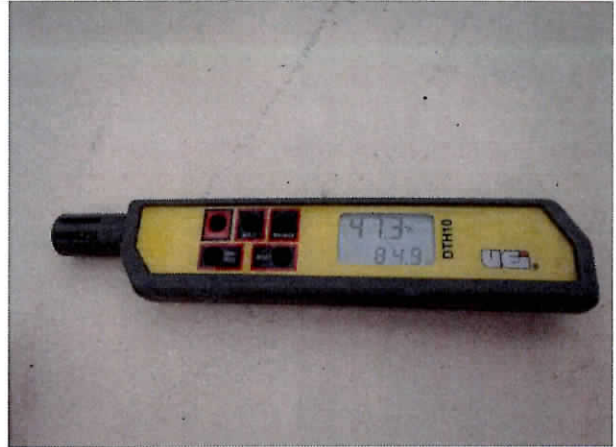
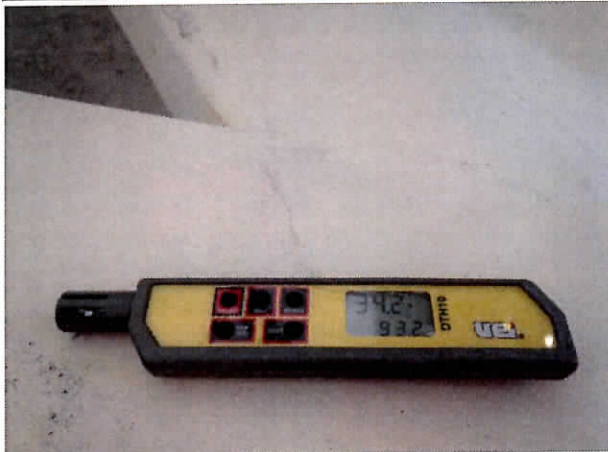
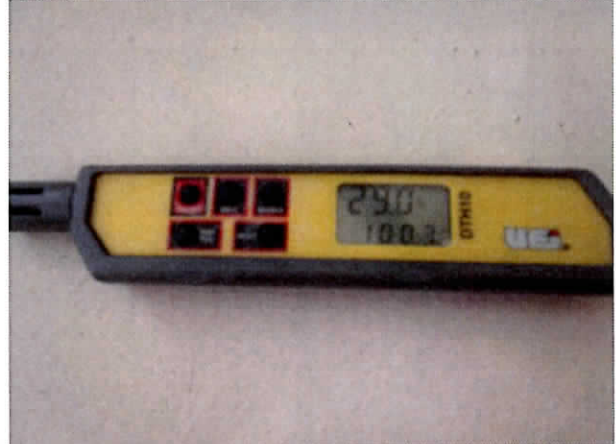
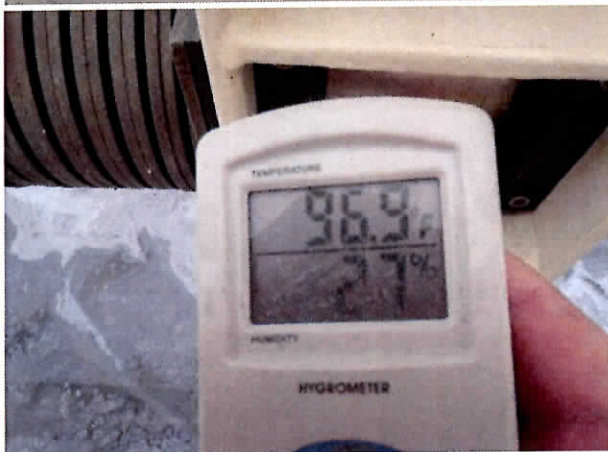
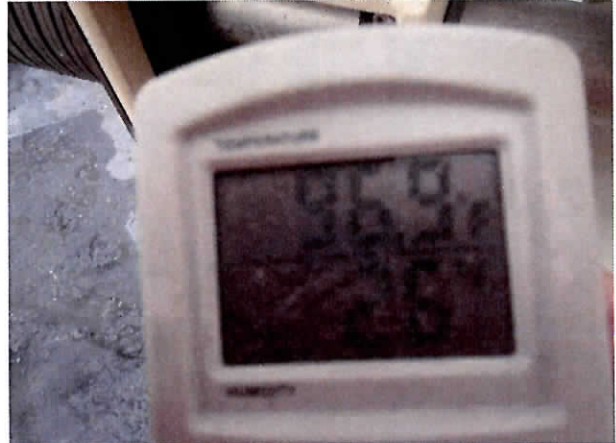
TOP SIX: Truss 2/3 holiday testing, T2/T3 tent temperature readings

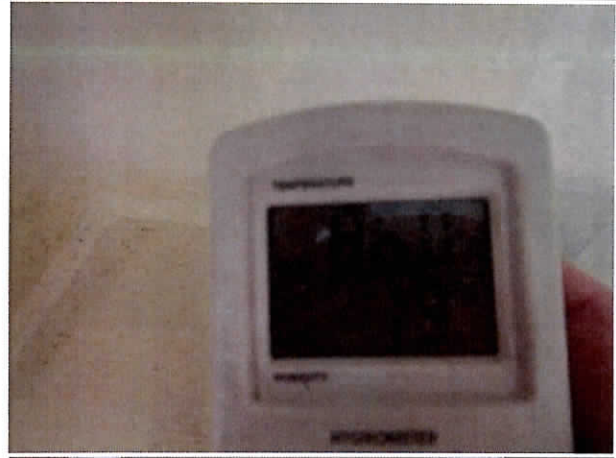
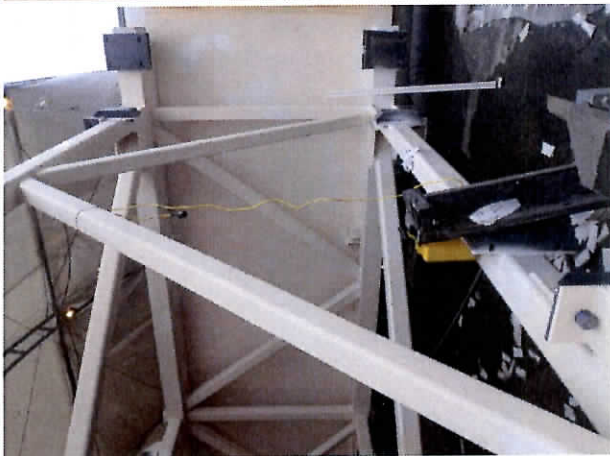
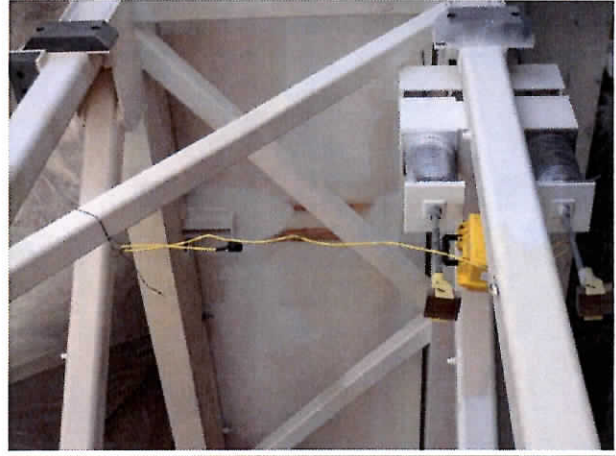
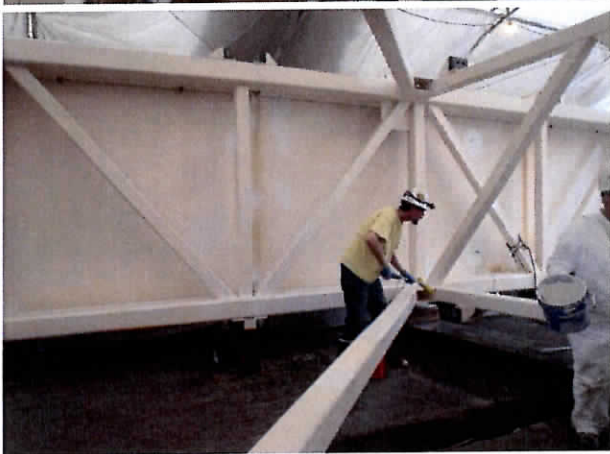
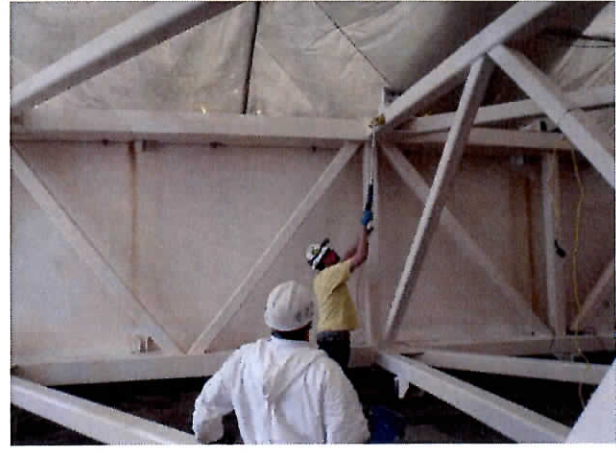
TOP SIX: Truss 2/3 holiday testing, T2/T3 tent temperature readings

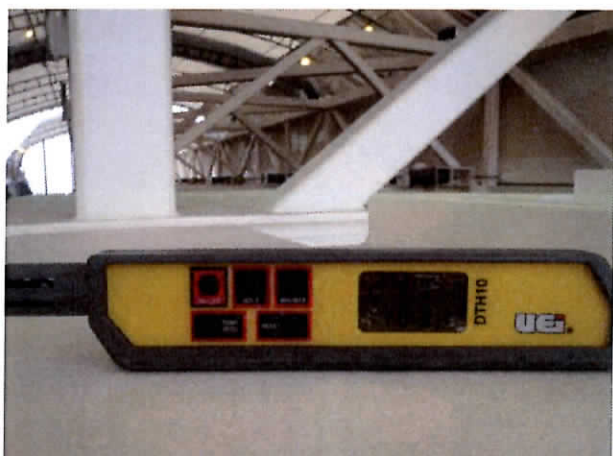
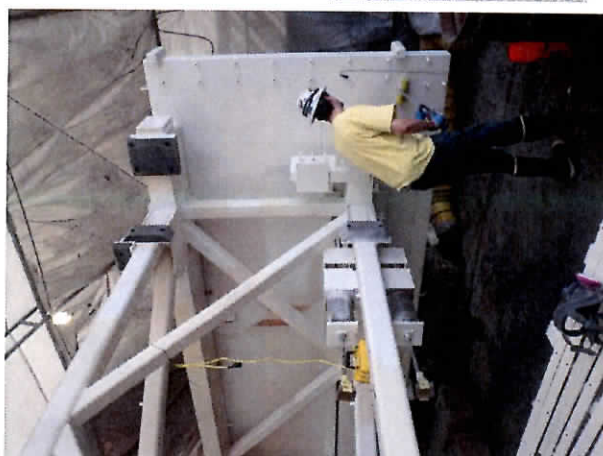
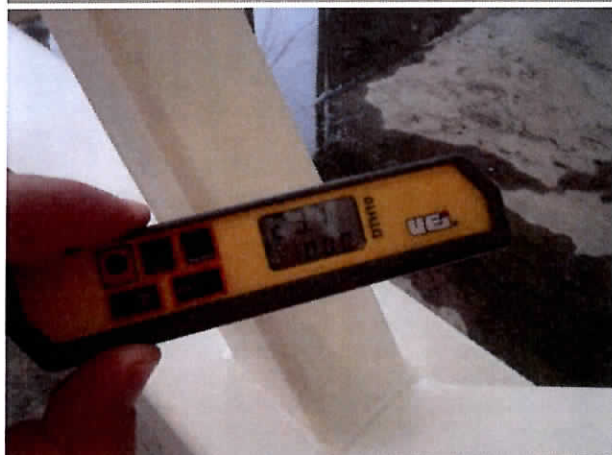
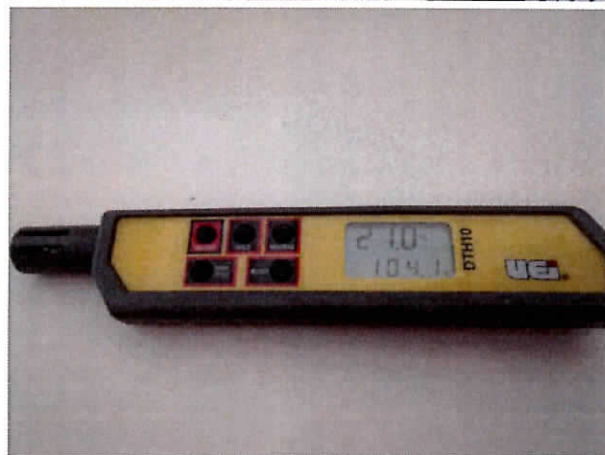
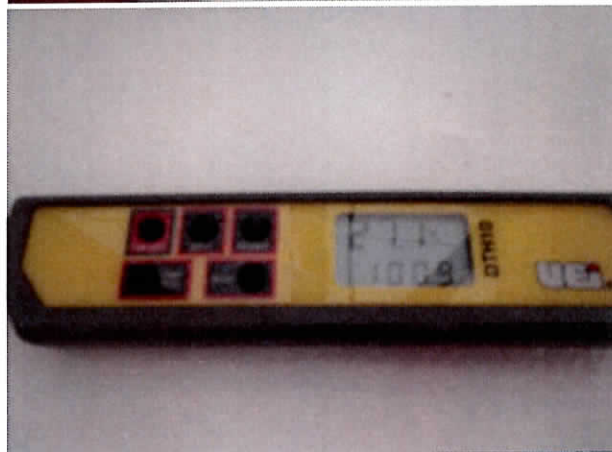
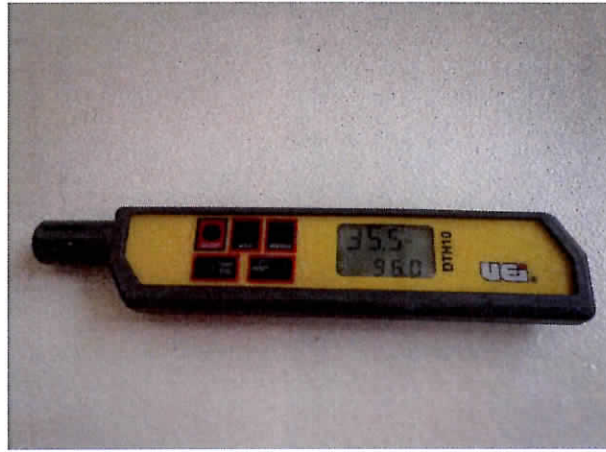
TOP SIX: Truss 2/3 and 1 holiday testing, T1 tent temperature readings

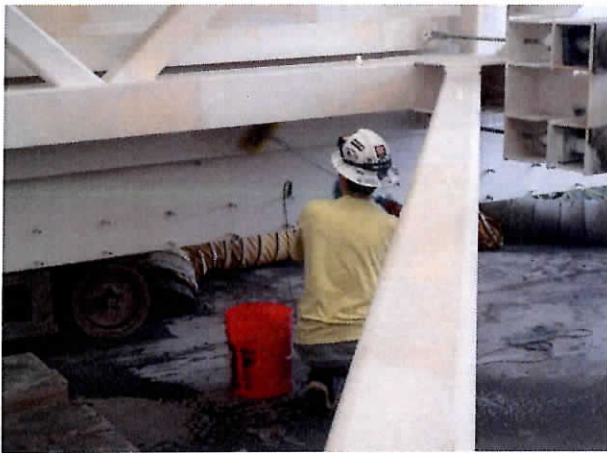
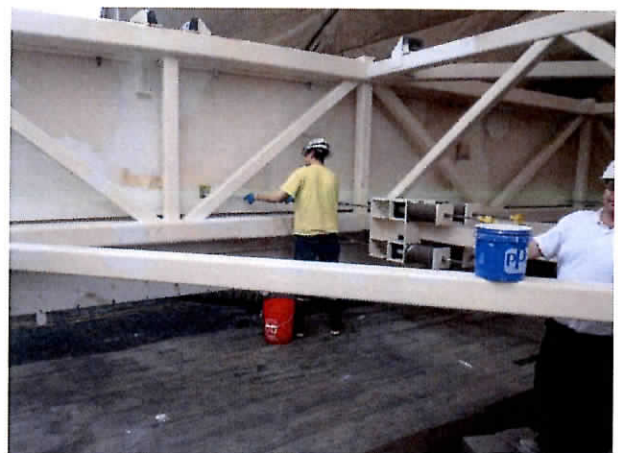
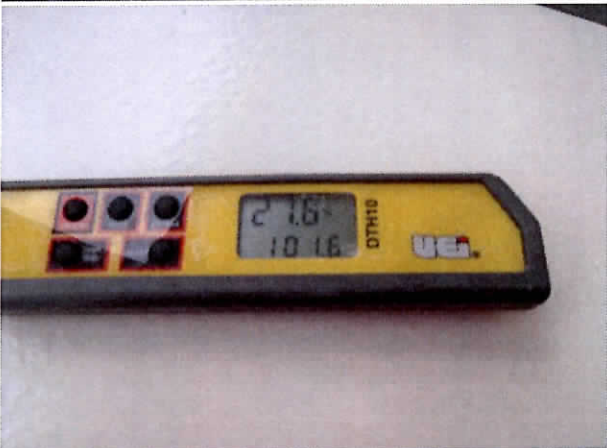
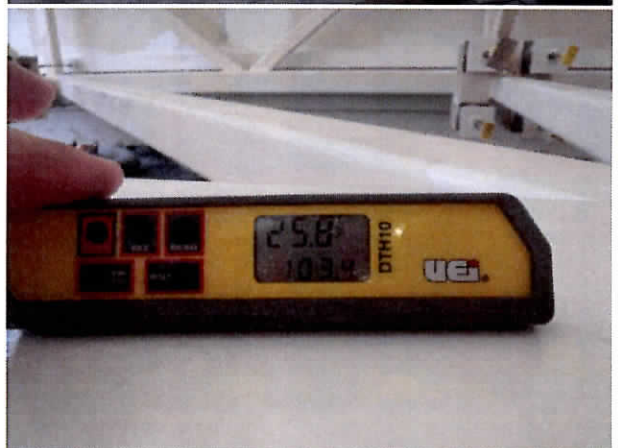
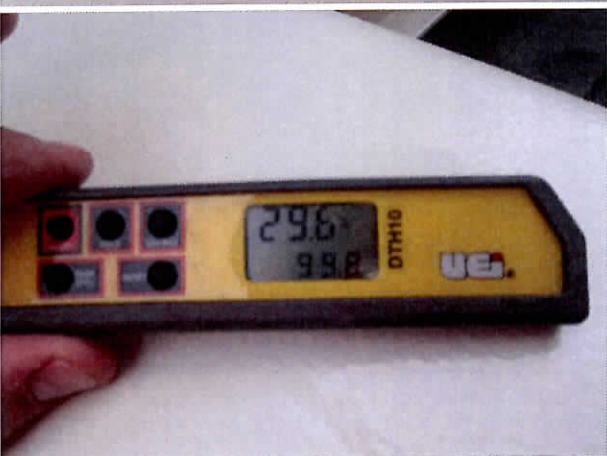
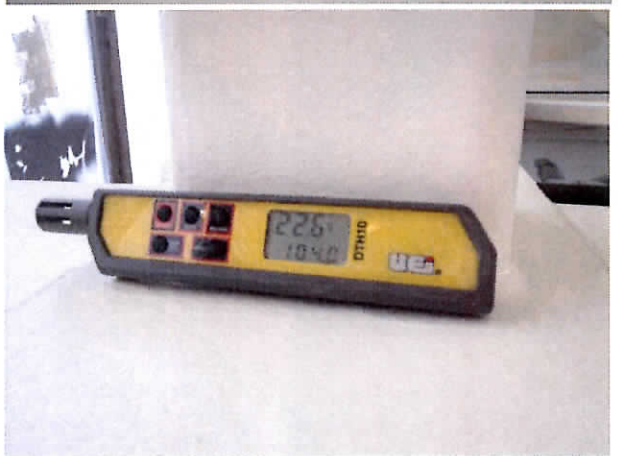
TOP SIX: Truss 1 holiday testing, T1 tent temperature readings

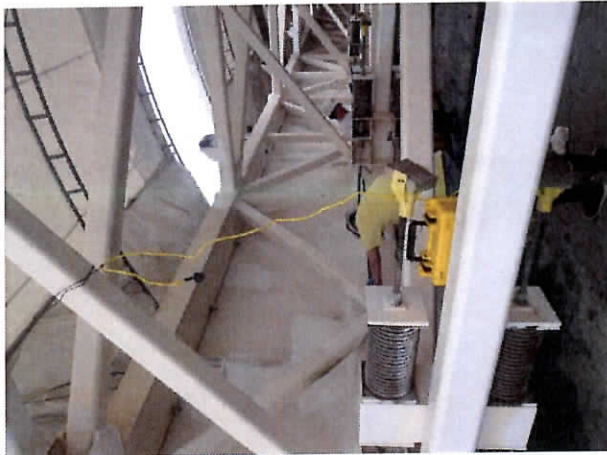
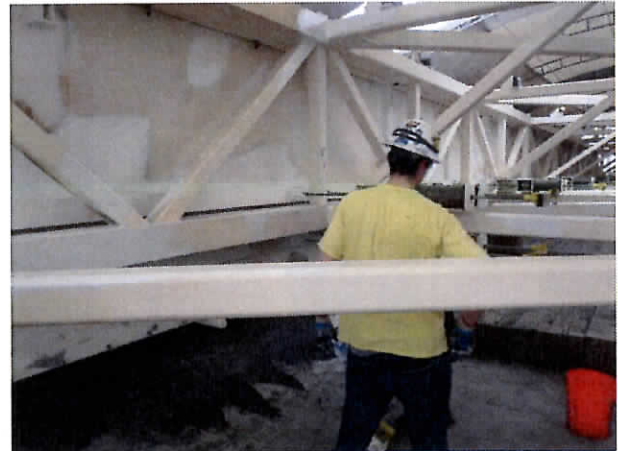
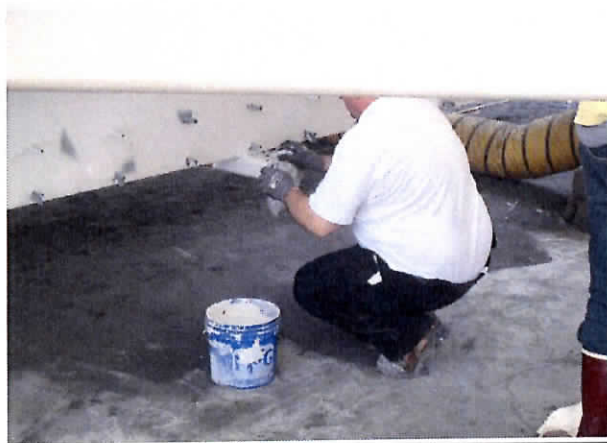
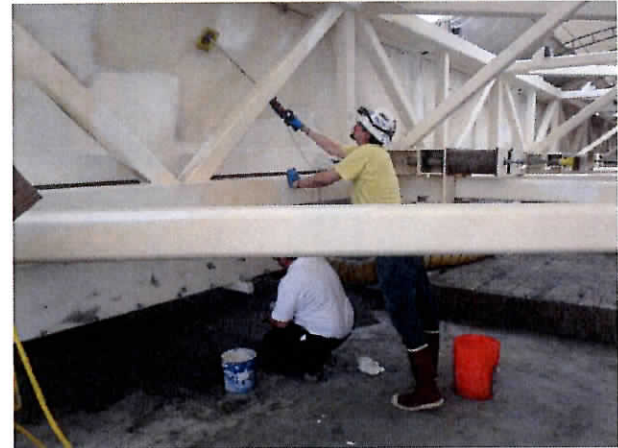
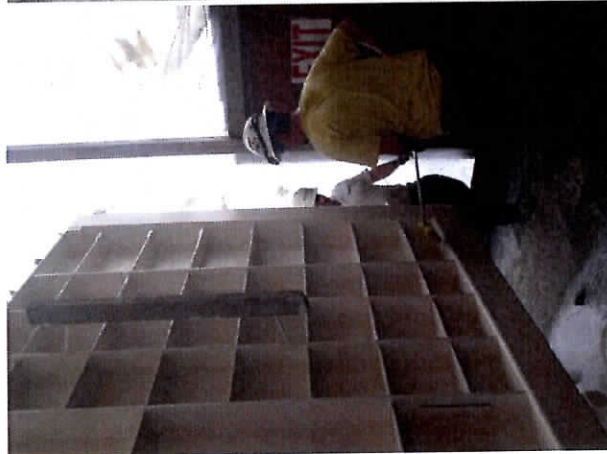
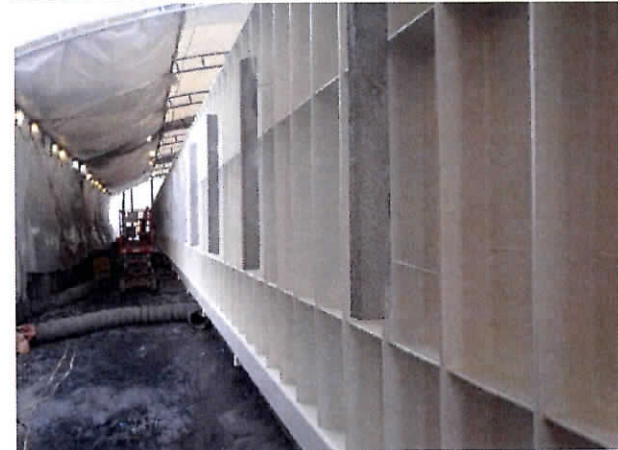
TOP SIX: Truss 1 holiday testing

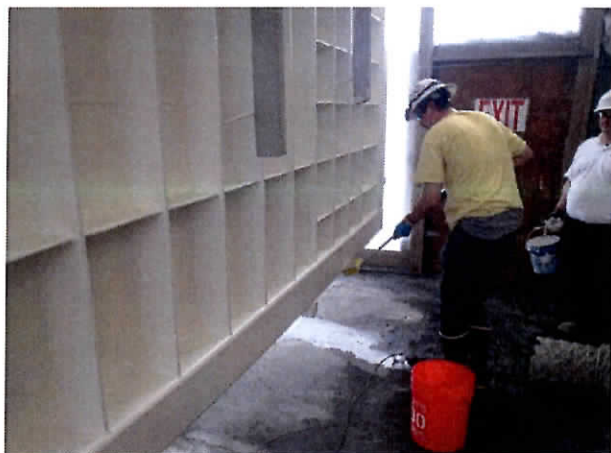
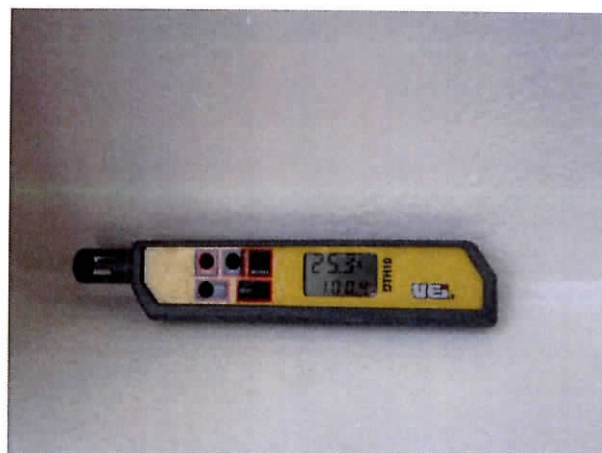
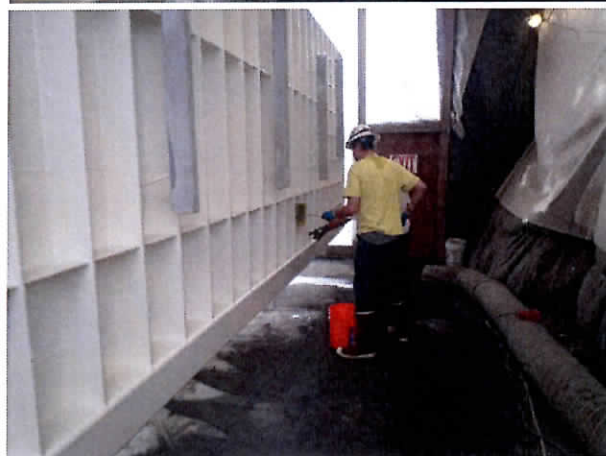
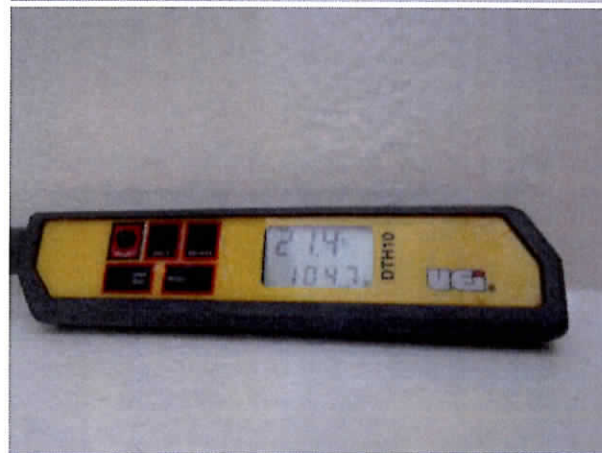
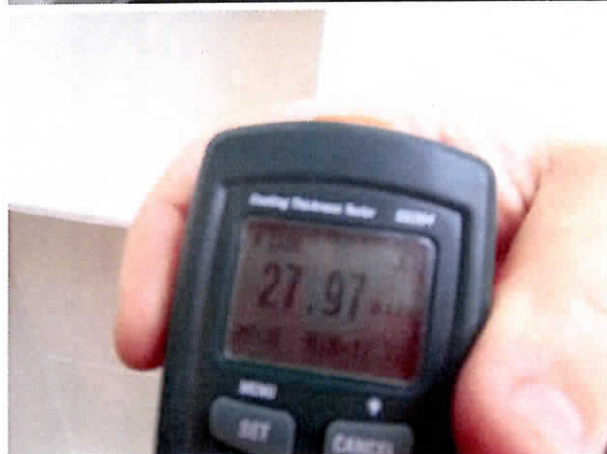
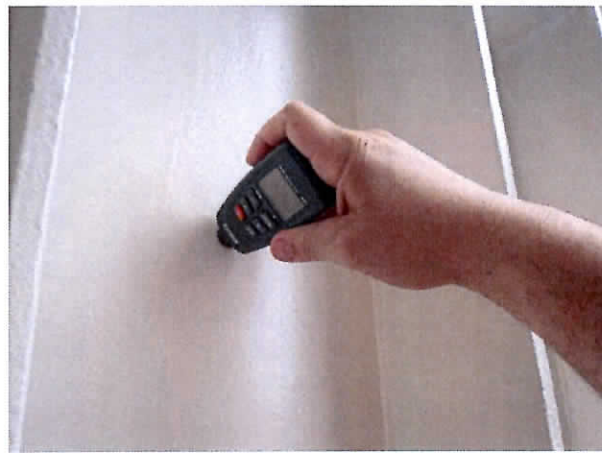
TOP SIX: Truss 1 DFT readings for top coat Dura-plate 235, holiday testing, T1 tent temperature readings

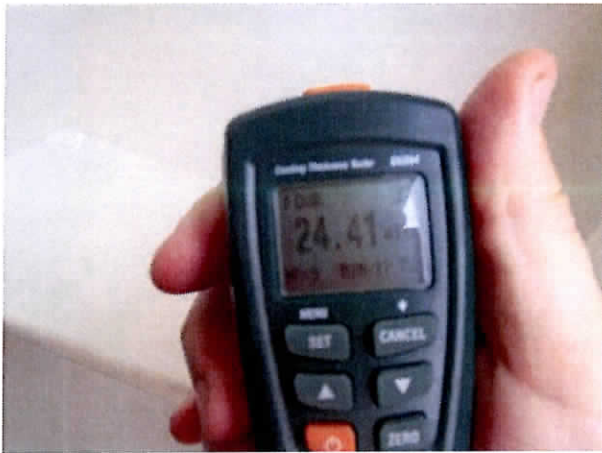
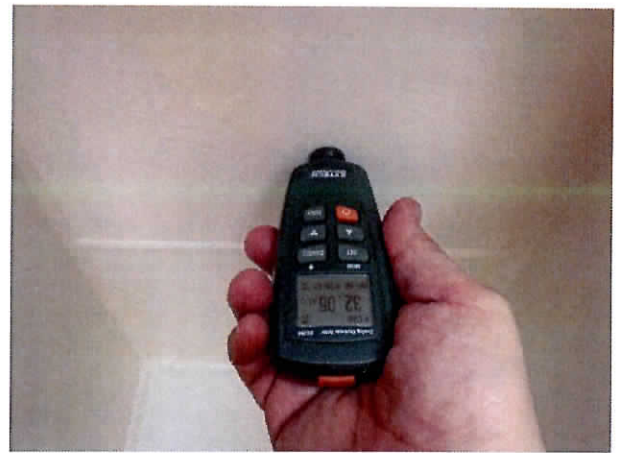
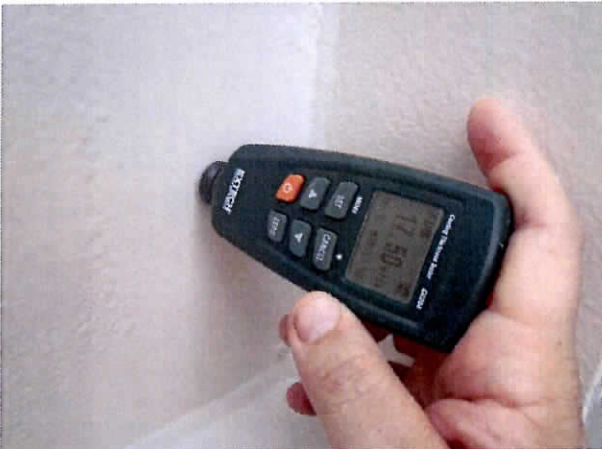
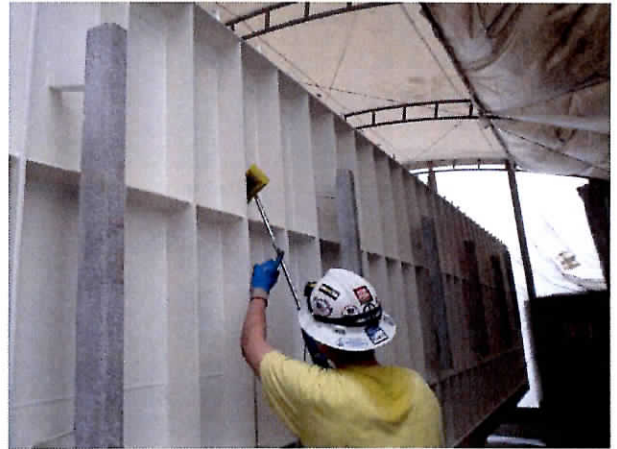
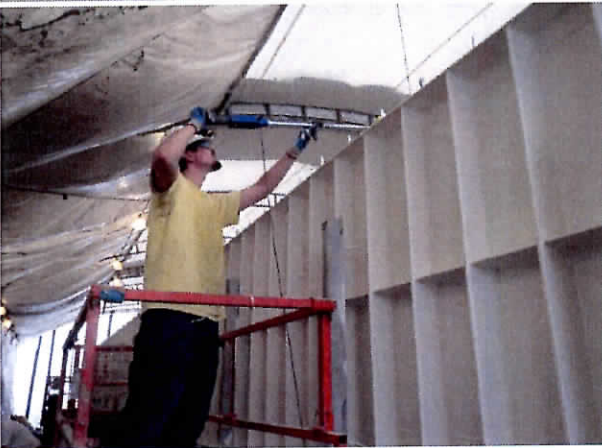
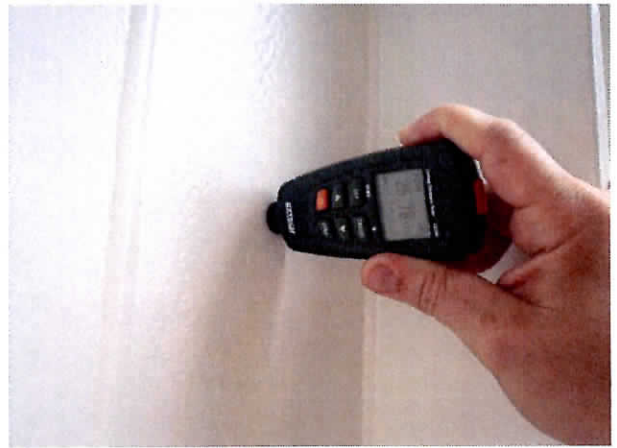
TOP SIX: Truss 1 DFT readings for top coat Dura-plate 235, holiday testing, T2/T3 tent temperature readings

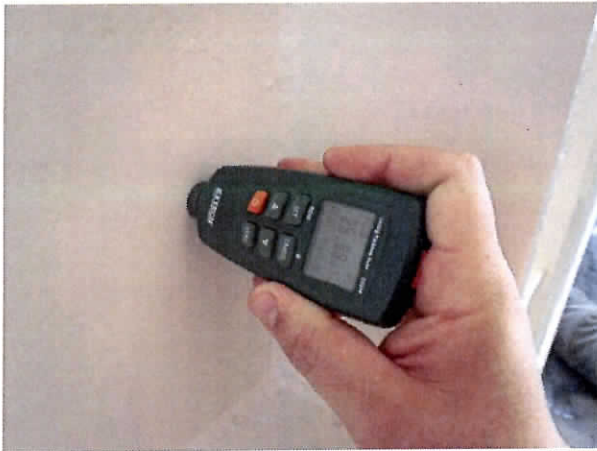
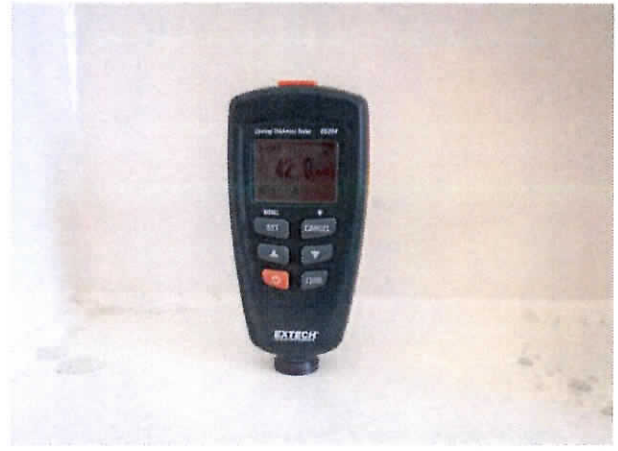
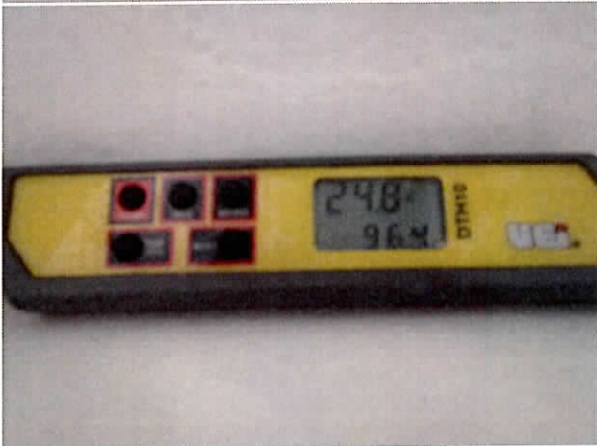
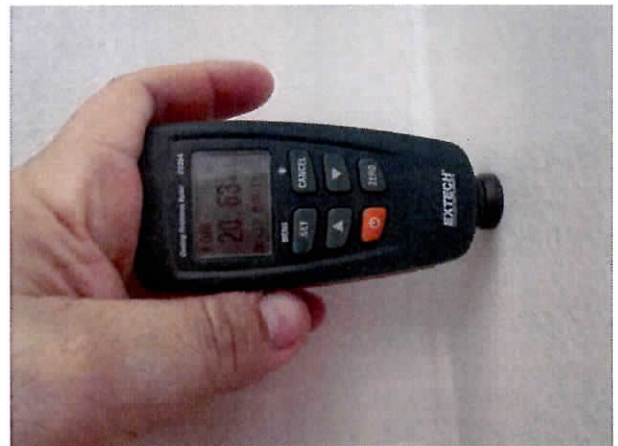
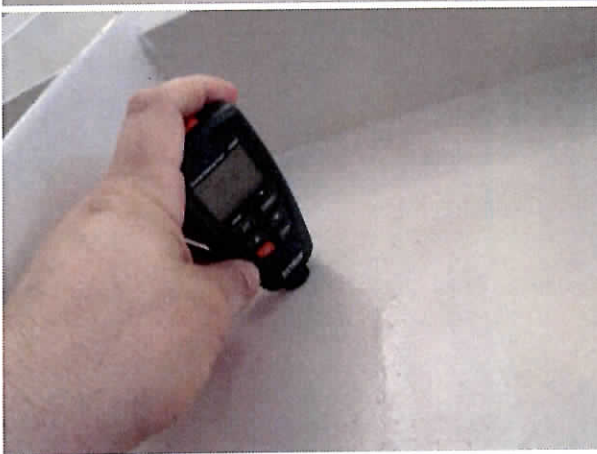
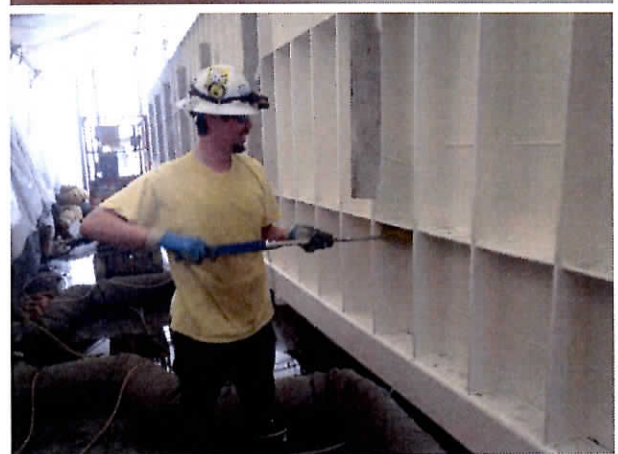
TOP SIX: Truss 1 DFT readings for top coat Dura-plate 235, holiday testing, T2/T3 tent temperature readings

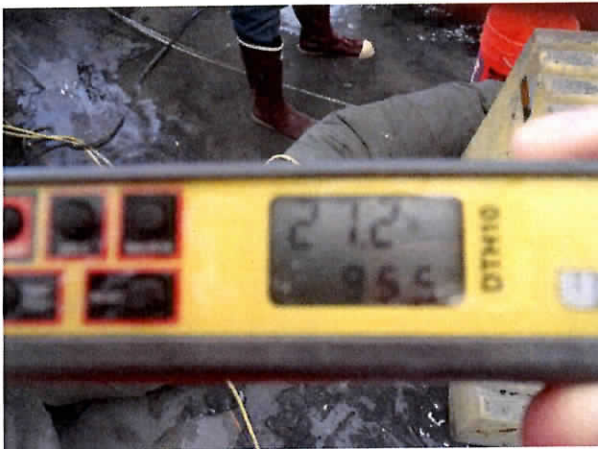
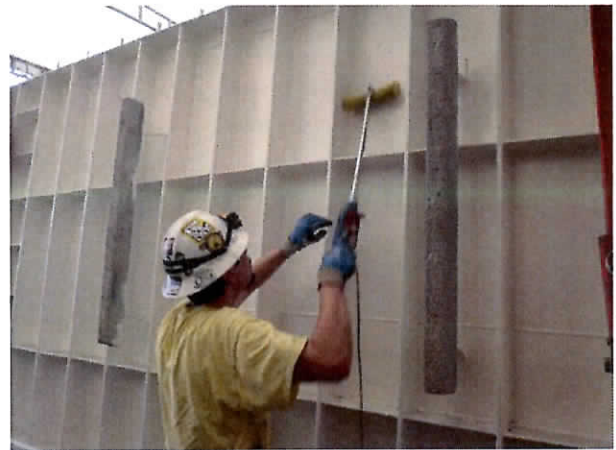
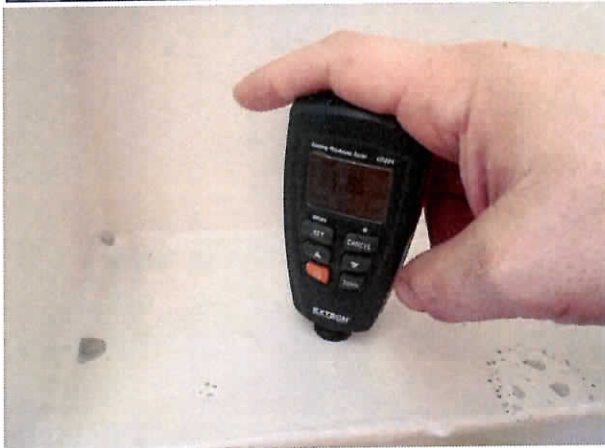
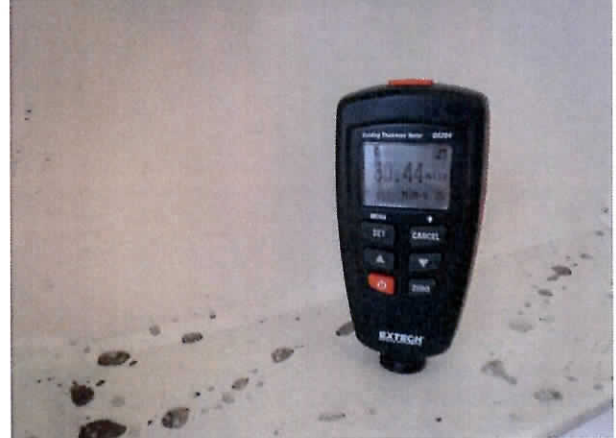
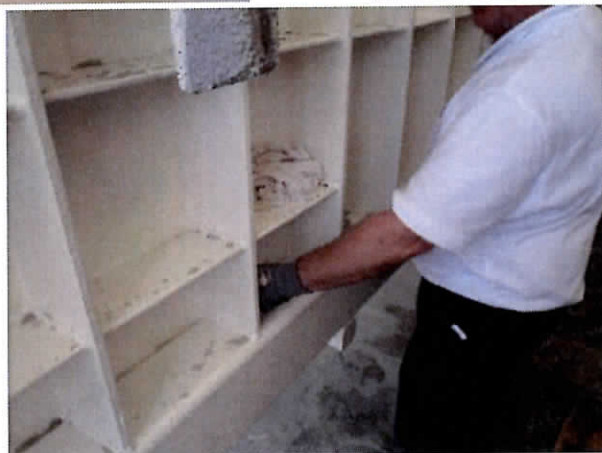
**TOP FIVE:** Truss 1 DFT readings for top coat Dura-plate 235, holiday testing, T2/T3 tent temperature readings

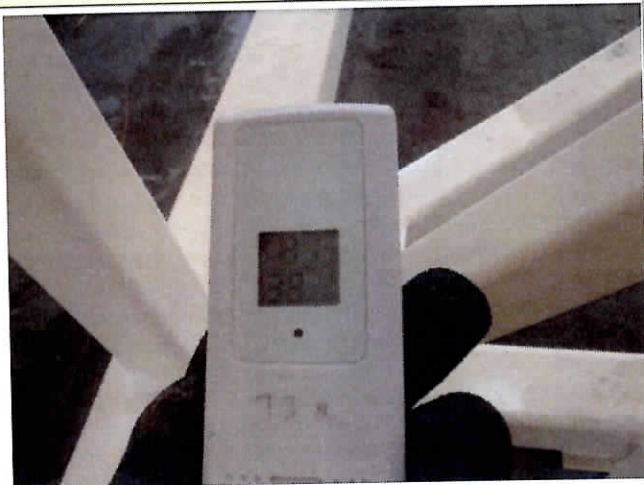
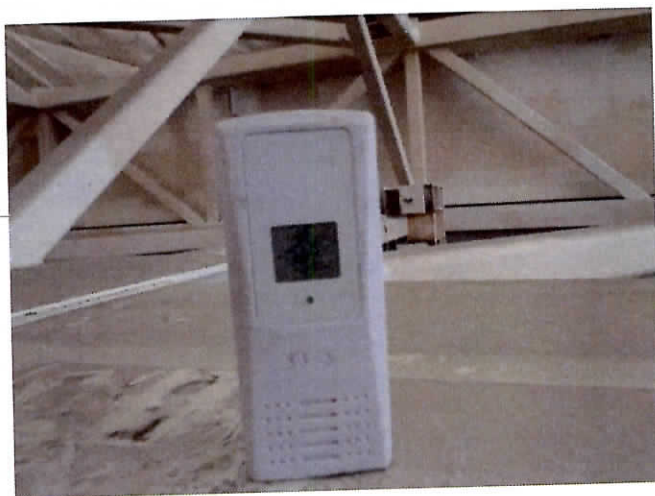
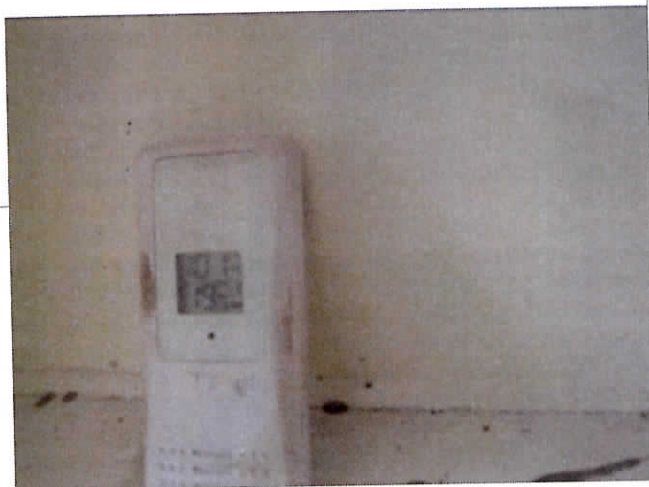
TOP SIX: Truss 2/3 temp (top left), truss 1 readings

*Gate Cure Schedule:* TRUSS 2/3: 6 day(s) cure, coldest area noted: 83.8 F, warmest area noted: 105.2 F, average tent temperature (of 10 Fluke Gauge readings): 99.1 F, average humidity 30%. TRUSS 1: 3 days cure, coldest area noted: 101.9 F, warmest area noted: 122.8 F, average tent temperature (of 10 Fluke Gauge readings): 108.5 F, average humidity 24%.

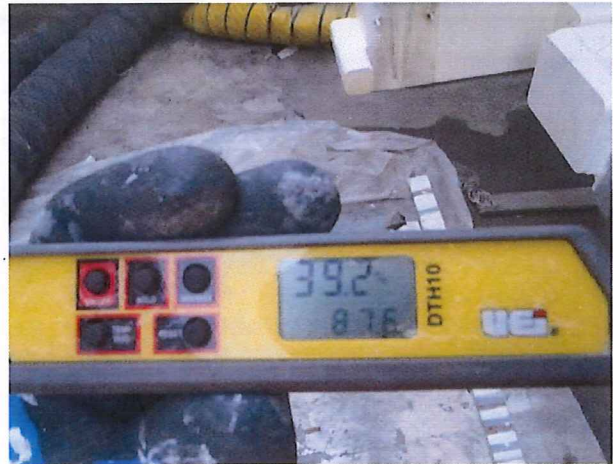
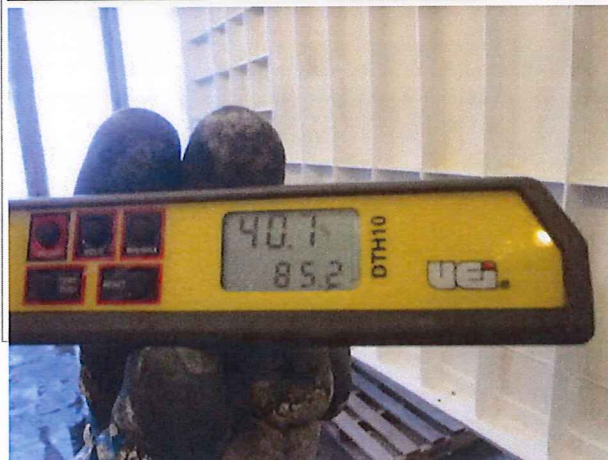
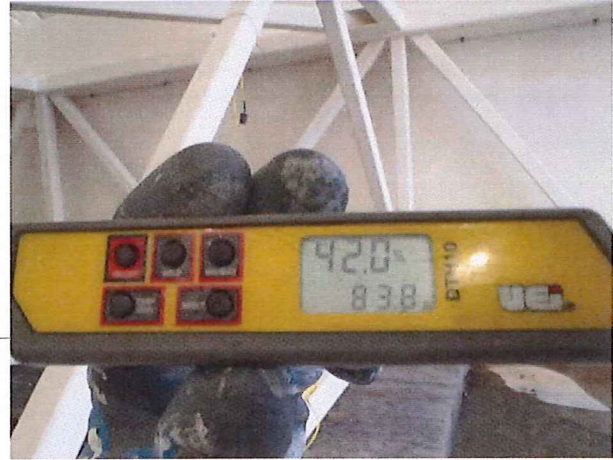
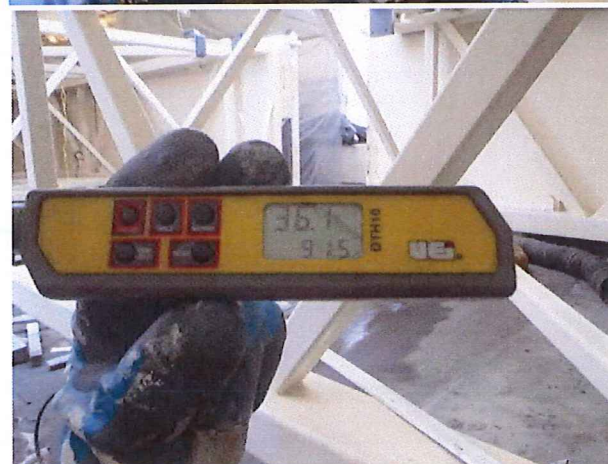
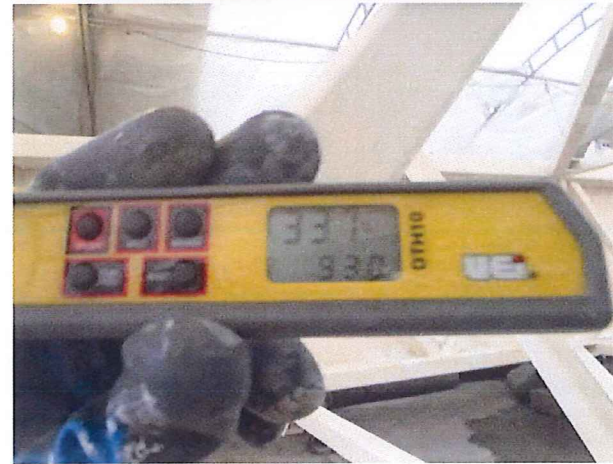
TOP SIX: Truss 2/3 tent temperature readings

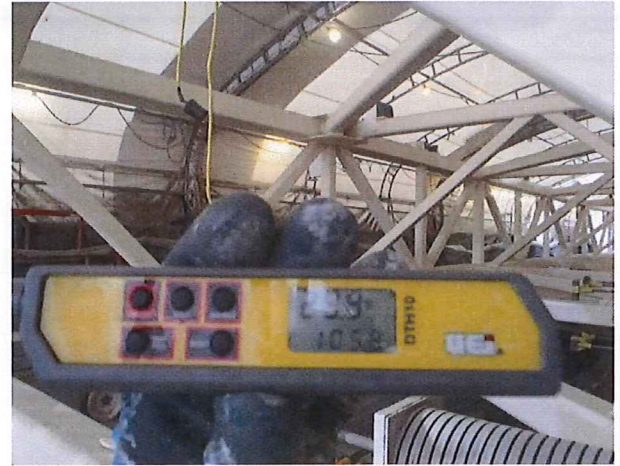
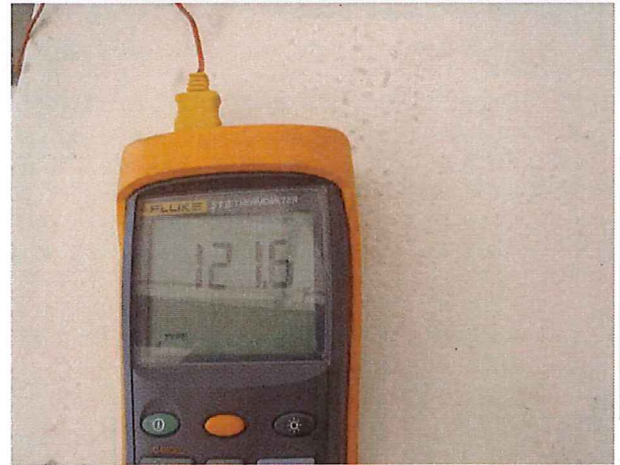
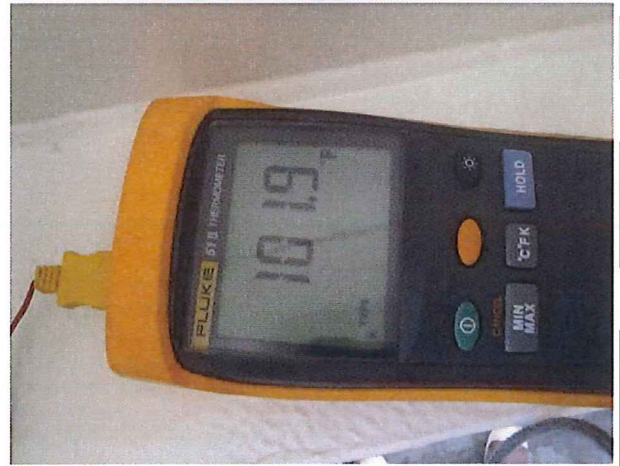
TOP TWO: Truss T2/T3 tent temperature readings  
BOTTOM FOUR: Truss T1 tent temperature readings
